Electrophysics Resource Center: Thermal Imaging

Secrets to a Successful Thermal Imaging-based Building Energy Audit

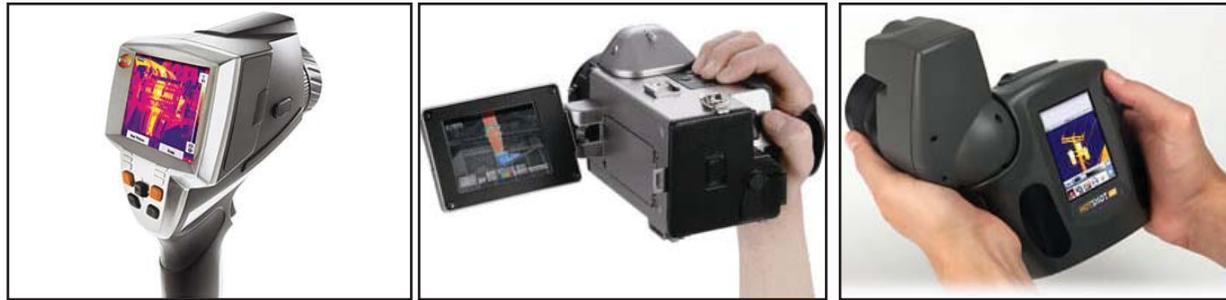
Figure 3 Infrared Cameras having Low, Medium and High resolution

EZ Therm 880
 160x120 Resolution

TVS-200
 320x240 Resolution

HotShot HD
 640x480 Resolution

As shown in the chart below, infrared cameras are available with a number of different features. Higher resolution cameras have the highest performance (such as best image quality and best ability to see defects) as well as the most features (such as an integrated visible camera, fusion of visible and thermal images and real-time video output) but also cost the most.

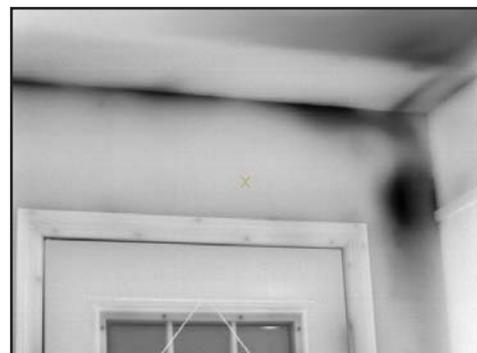
Figure 6: Poor workmanship

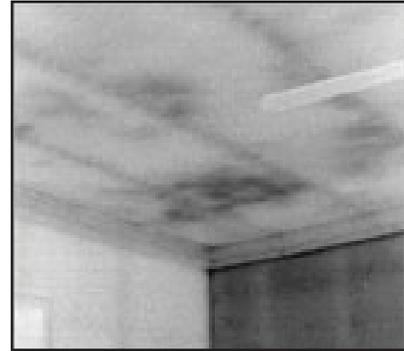
Figure 8: Wet ceiling insulation

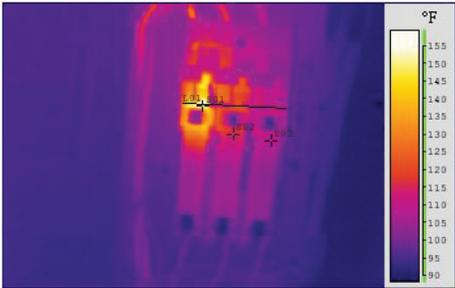
**IR image file:
sca_panel 2.eif**

Incident Summary		Inspection Detail	
Equipment	Chiller Room Fuse Block	Thermographer	Bill Martin
Incident Date	6/13/2006 11:19:29 AM	Component Temperature	154
Recommendation	Check fuse clip tension	Reference Temperature	117
Severity	Medium	Temperature Rise	36.4
Units	°F	Component Emissivity	0.95
Global Emissivity	1.00	Background Temperature	60

Re-inspect after repair is made and check for imbalanced load before taking circuit off load just to make certain it is a connection related problem.
